# GUIDELINES FOR USE OF **ASPHALT OVERLAYS** TO REHABILITATE PCC PAVEMENTS

National Center for Asphalt Technology  
At Auburn University

January 2024

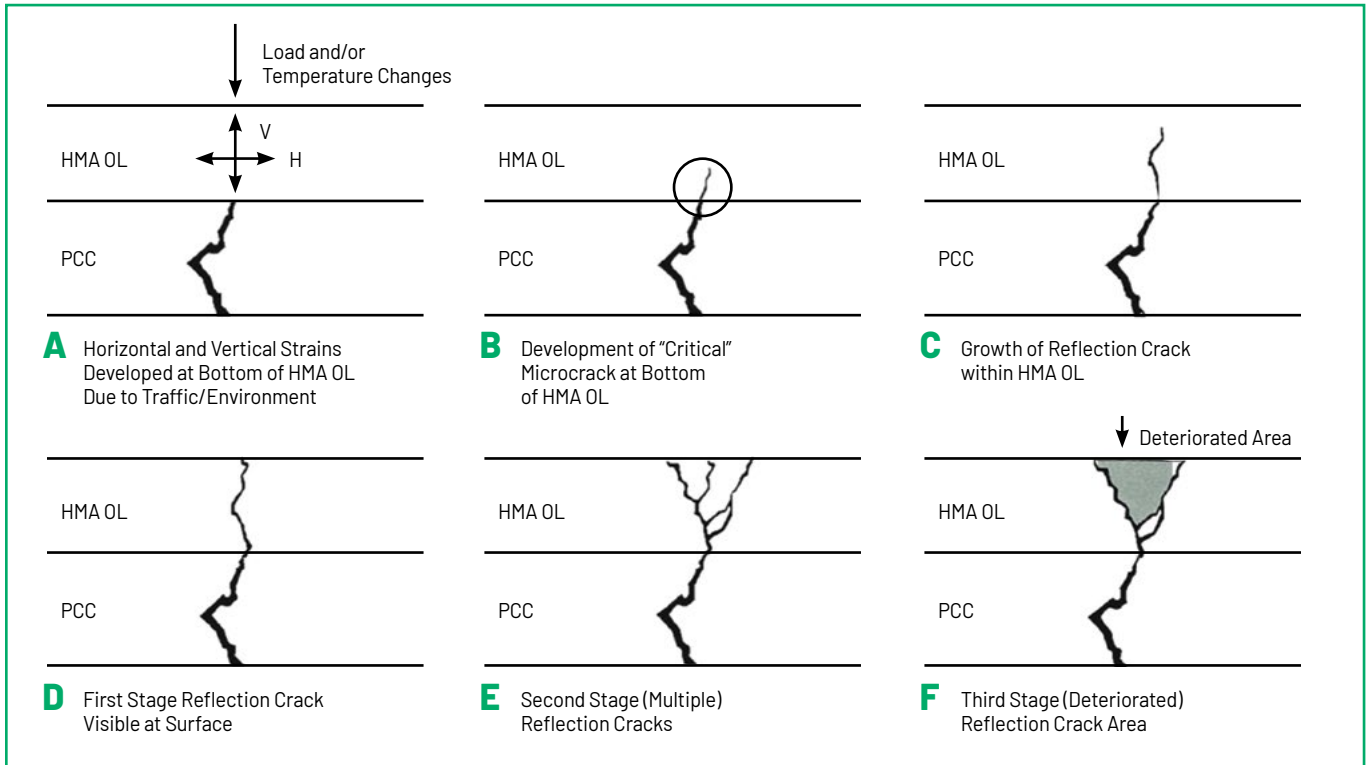
**Figure 2.3 Growth Mechanisms Associated with Reflection Cracking (NAPA 1999)**

In summary, asphalt overlays on PCC pavements are subjected to several high strain mechanisms that can occur simultaneously. As illustrated in Figure 2.3a, the combined strain and stress concentrations at the bottom of the asphalt overlay eventually cause cracks at the bottom of the asphalt overlay (Figure 2.3b). Due to cyclic temperature changes and repeated traffic loads, the cracks will grow and reflect upwards to the surface of the asphalt overlay (Figure 2.3c and d). As this process continues, multiple reflection cracks will form, causing portions of the asphalt overlay to deteriorate (Figure 2.3e and f). Figure 2.4 shows a deteriorated reflection crack area in an asphalt overlay over an existing PCC pavement, leading to reduced serviceability and shortened service life of the asphalt overlay. Thus, reflection cracking must be addressed in the rehabilitation selection process, described further in the following section.

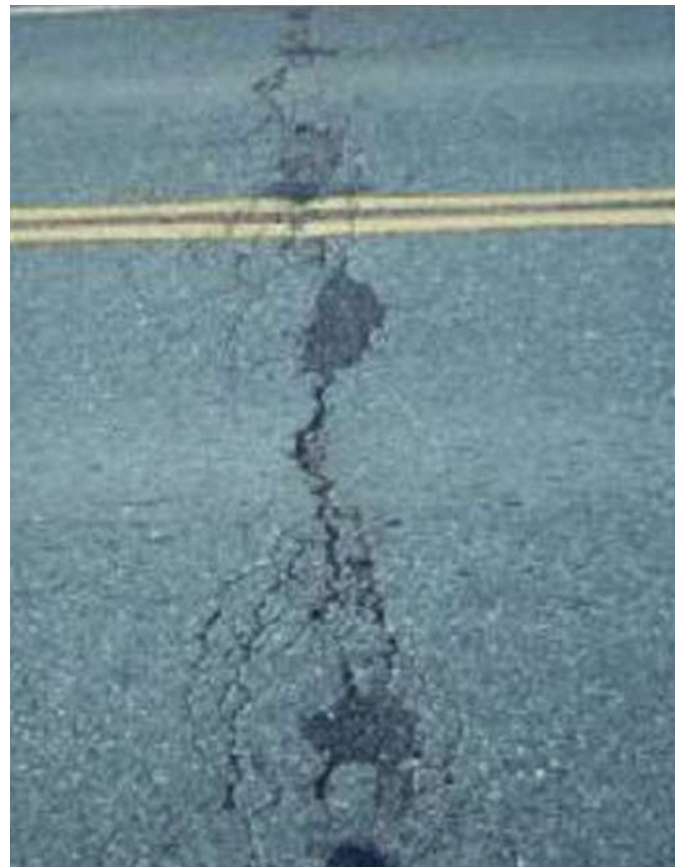
**Figure 2.4 Deteriorated Reflection Crack Area (NAPA 1999)**

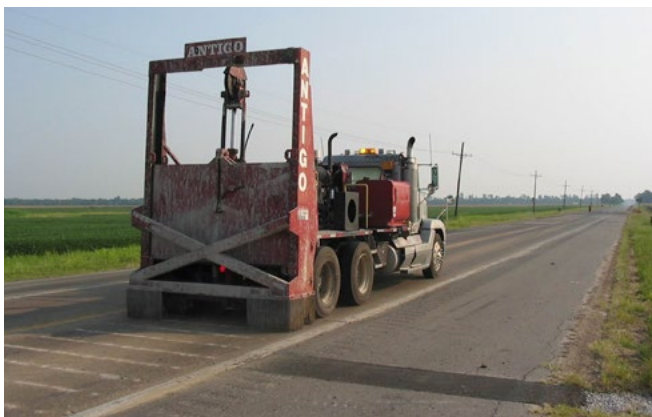
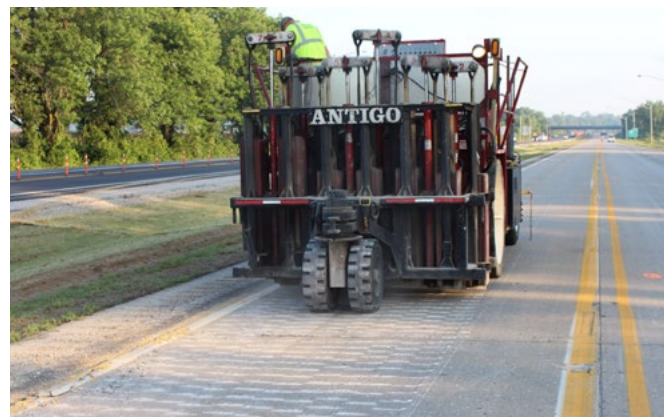
a. Cracking Operation for C&S

b. Breaking Operation for B&S

**Figure 3.1** Fractured PCC after Cracking and Breaking Operations (Courtesy of Antigo)

The two techniques differ in the level of effort applied to fracture the PCC slabs. C&S (Figure 3.1(a)) is intended to produce tight cracks in JPCP that still allow for load transfer with minimal loss of structural integrity, while B&S (Figure 3.1(b)) requires more effort to break or debond steel reinforcement to properly seat the JRCP slabs. The maximum crack spacing (or resulting fragment size) should be less than 30 inches for C&S projects and less than 12 to 18 inches for B&S projects (Rada 1992; NAPA 1999).

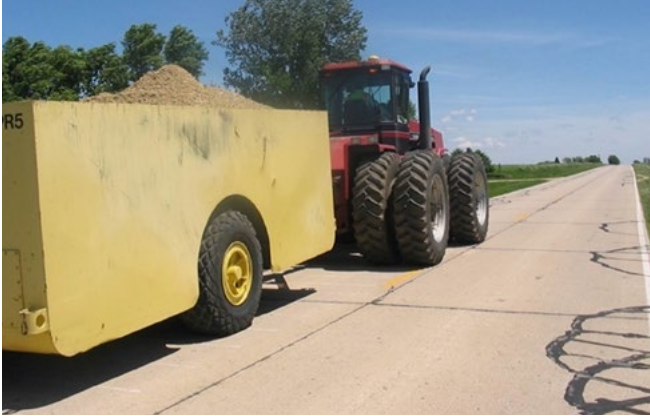
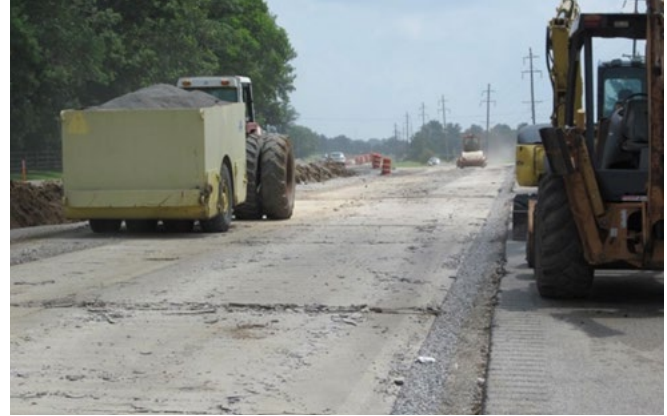
a. Seating after Cracking

b. Seating after Breaking

**Figure 3.2 Seating Operations for C&S and B&S** (Courtesy of Antigo)

Both techniques involve firmly seating the fractured slabs using a 35 to 50-ton pneumatic roller (Figure 3.2). Two passes of the pneumatic roller are recommended for the C&S process, while five to seven passes are recommended for the B&S process to ensure the steel is fully ruptured. However, care should be taken to not over-roll the slabs to avoid reducing the interlocking of the pieces, especially for C&S, which can negatively impact load transfer and structural integrity. Good construction results in through-slab cracking to produce the desired PCC segment size.

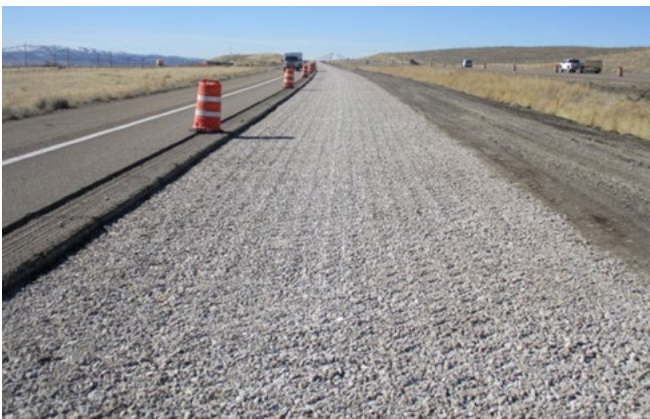
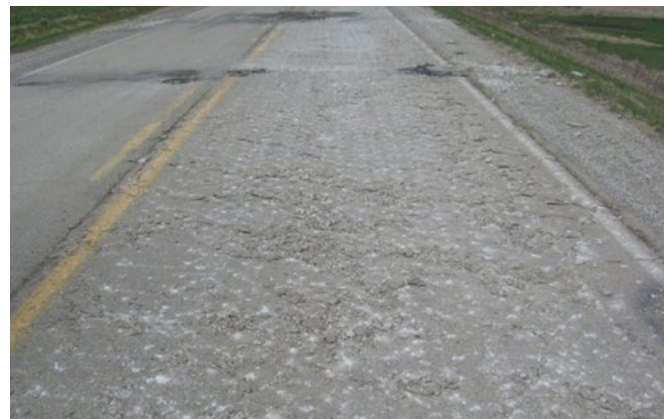
a. Traditional Rubblization

b. Modified Rubblization

**Figure 3.3 Comparison of Traditional and Modified Rubblization** (Courtesy of Antigo)

Rubblization is an effective technique for eliminating reflection cracking in PCC slabs, but it requires adequate support from the base and subgrade. If the underlying support is poor, the PCC pavement may not be rubblized to the required extent, affecting the performance of the asphalt overlay. To address this challenge, Antigo Construction, Inc. (Antigo) developed a modified rubblization technique that uses less fracture energy to create a stiffer rubblized concrete layer that supports construction operations and asphalt overlays while effectively eliminating reflection cracking (Buncher et al. 2008). This modified method specifies a maximum particle size of 12 inches at the surface and 15 inches at the bottom of the slab, which is different from the typical 3 to 8 inches specified in IS-117. Figure 3.3 illustrates the difference between traditional rubblization and modified rubblization methods.

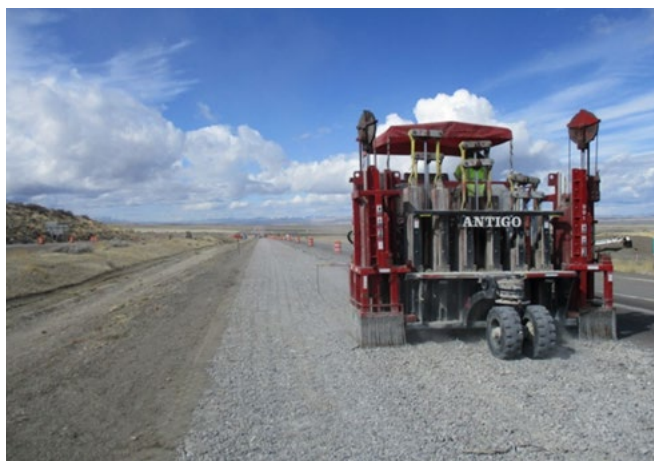
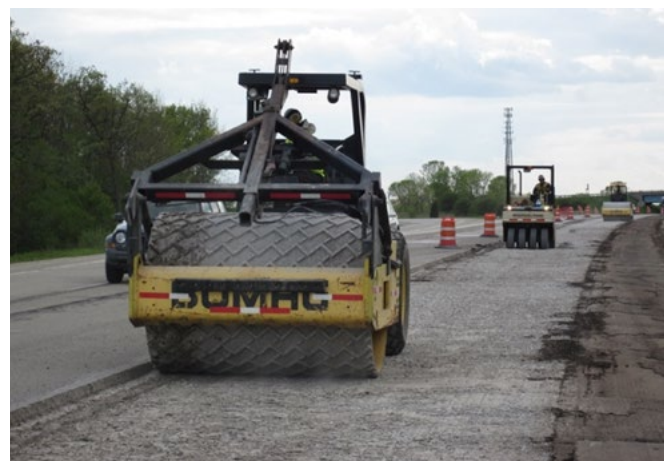
a. Multi-Head Breaker

b. Three-Roller Compaction Process

**Figure 3.4** Multi-Head Breaker and Compaction Equipment for Rubblization of PCC Pavements (Courtesy of Antigo)

The MHB has twelve to sixteen 1,200- to 1,700-lb drop hammers arranged in pairs, half in a forward row and half diagonally offset in a rear row. This design ensures continuous breakage from side to side. Each pair of hammers is attached to a hydraulic lift cylinder and can develop 1,000 to 8,000 ft-lb of energy based on lift height and cycle at a rate of 30 to 35 impacts per minute. The drop height can be adjusted during operation to control breaking energy on PCC pavement. The machine is 8 feet wide with 12 hammers, each 8 inches wide, and can have wings added to each side for a total width of up to 13 ft. With individual control of each lifting cylinder, the breaking width can range from 2.67 ft to 13 ft. The MHB is capable of rubblizing a full lane width of pavement in a single pass. It is equipped with a screen to protect personnel and vehicles from flying chips during fracturing.

After the fracturing process, a smooth steel drum vibratory roller with raised Z-grids on the drum (Z-grid roller) with a gross weight of at least 10 tons is used in the vibratory mode for two passes to further fracture the surface particles and to begin to settle and seat the rubblized pavement. A pneumatic-tire roller with a gross weight of 10 to 25 tons is then used to further settle and seat the rubblized pavement for slab thicknesses of 8 inches (203 mm) or thicker. Finally, a smooth steel drum vibratory roller with a gross weight of at least 10 tons, operated in the vibratory mode, is used to settle the rubblized pavement and provide a smooth surface for the asphalt concrete overlay. Figure 3.4 shows an MHB in operation and three rollers used for compacting the rubblized pavement.

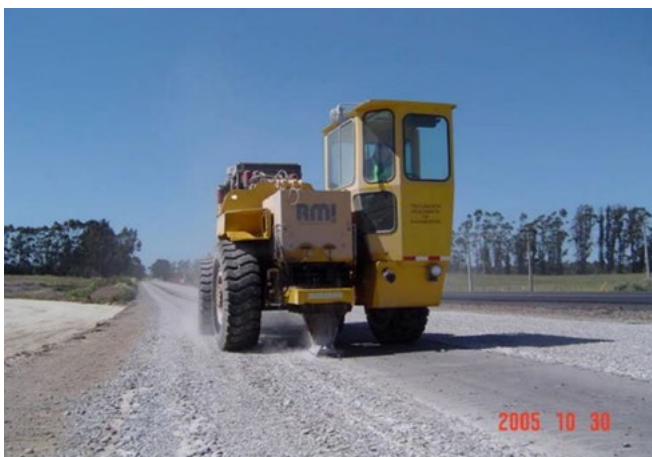
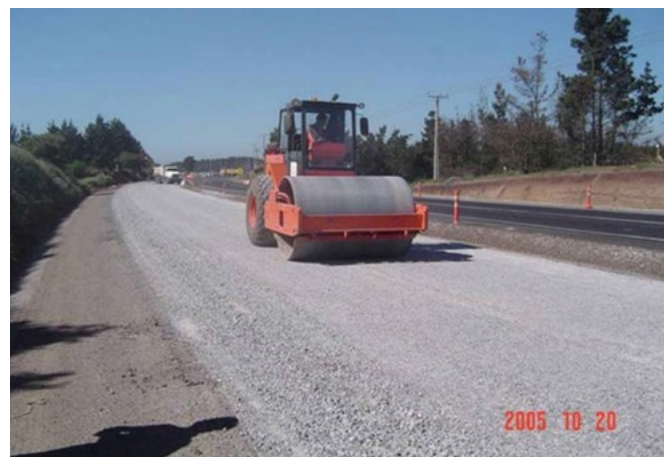
a. Resonant Frequency Breaker

b. Compaction with a Smooth Steel Roller

The breaking process usually starts at the pavement's outside edge and continues toward the centerline, as illustrated in Figure 3.5(a). The breaking pattern is around 8 inches wide, typically requiring 18 to 20 passes to break a 12-foot wide lane. To avoid disruptions to the base and damage to underground structures, the RFB is generally operated at a maximum amplitude of one inch. The machine may encroach on an adjacent lane by about 3 to 5 ft to rubblize near the pavement's centerline. Since the RFB has wheel loads of 20,000 lbs. and a total weight of 60,000 to 70,000 lbs., it is important that the fractured pavement, shoulder, and subgrade be able to support multiple passes of the equipment. Proof rolling should be performed on the rubblized areas using a heavy pneumatic roller. If any weak or unstable areas are identified, they must be removed and replaced with full depth asphalt concrete or flexible base material.

After the fracturing process, two to four passes of a smooth 10-ton tandem vibratory roller at a low-amplitude and high-frequency setting are often used to settle the rubblized pavement. A typical asphalt concrete roller can be used. Some agencies may require an 8-to-10-ton pneumatic roller to further seat the fractured pavement before placing the overlay. For example, the Louisiana DOT requires one pass with a pneumatic-tire roller after the initial pass with the vibratory roller. Two additional passes with the vibratory roller are made to settle the rubblized pavement and provide a smooth surface for the asphalt overlay. Figure 3.5 shows an RFB in operation and a smooth steel roller for compaction.

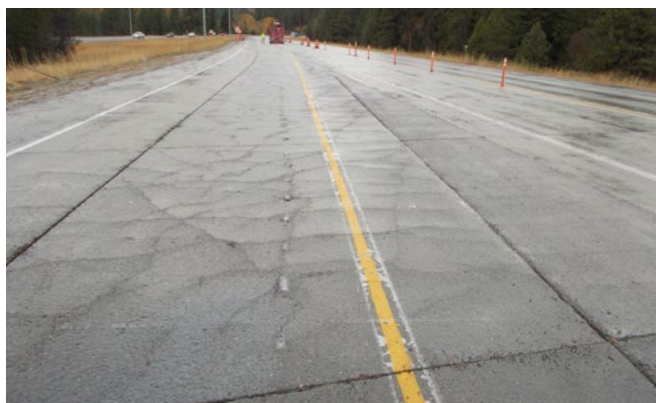
**Figure 3.6 Cracking Pattern of Cracked and Seated PCC Slabs** (Courtesy of Antigo)

- Before starting the fracturing process, removing material from a previous asphalt overlay is important. Failure to do so will significantly decrease the effectiveness of these techniques, as much of the fracture energy will be absorbed by the asphalt overlay.
- A test strip should be constructed at the start of the project to ensure the equipment and slab fracturing process are adequate to achieve the desired cracking pattern for through-slab cracking and acceptable PCC segmentation without causing excessive damage to the existing PCC surface.
- The crack spacing for the slab fracturing process can vary depending on the type of existing PCC pavements. The cracking pattern and fractured slab size can be verified by spraying water on the surface of the slabs immediately after the fracturing process. (Figure 3.6).

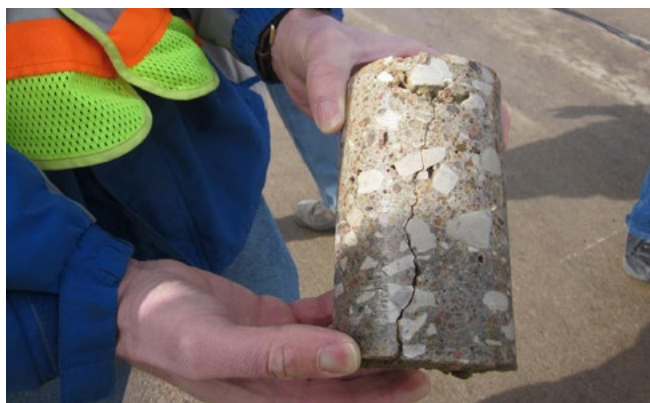
**Figure 3.7 Coring for Verifying Through-Slab Cracking** (Courtesy of Antigo)

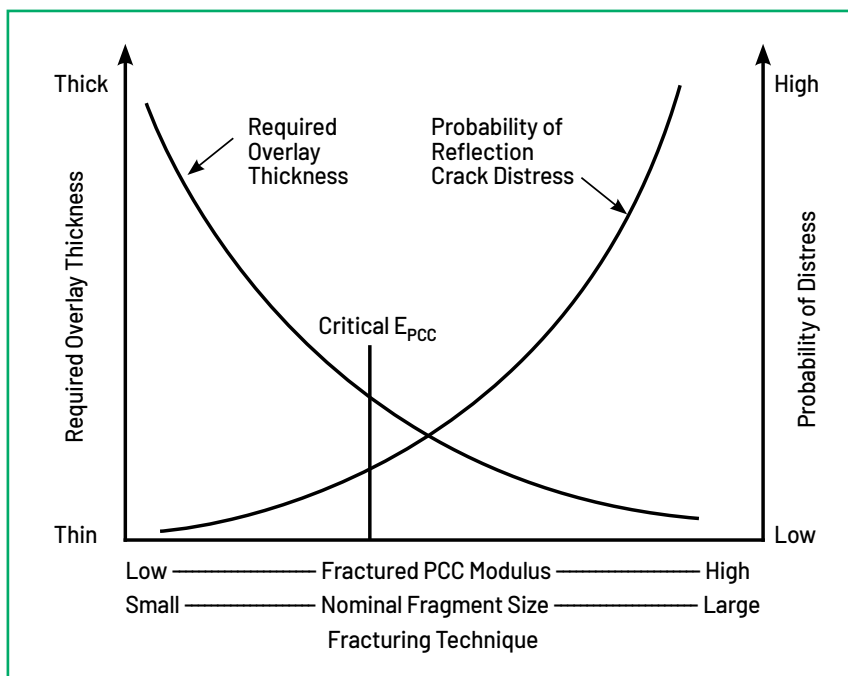
**Figure 4.1** Effect of Fractured PCC Modulus on Overlay Thickness and Probability of Reflection Cracking (Decker 2006)

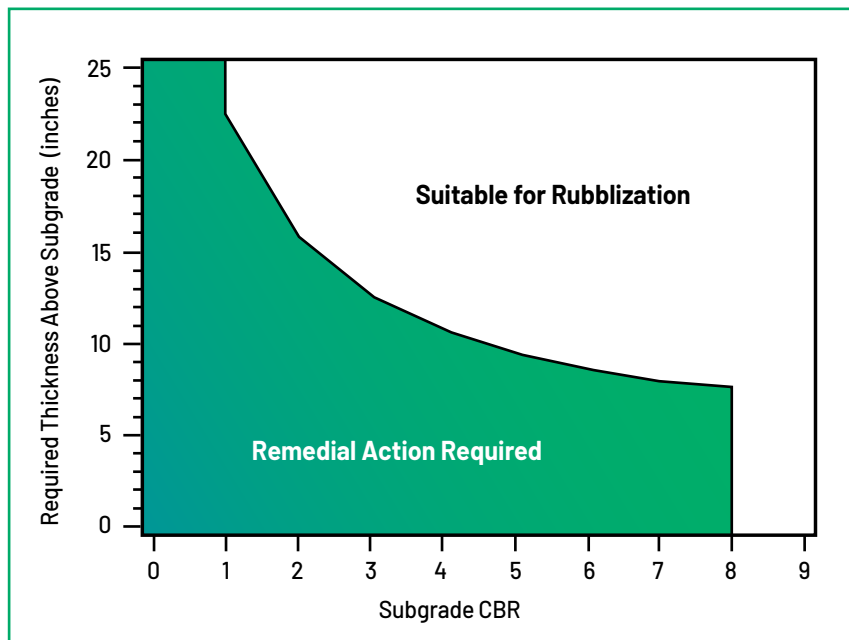
**Figure 4.2 Adequacy of Subsurface Layers for Rubblization** (WisDOT 2019)

- **Subsurface Conditions.** Fracturing a PCC slab requires adequate support from the underlying layers and subgrade to ensure consistent fracturing and facilitate construction, particularly for rubblization, which involves higher fracture energy. The suitability of the subsurface condition for rubblization can be determined by assessing the relationship between subgrade support, based on CBR determined from testing of recent soil samples, and the total thickness of pavement layers above the subgrade, including subbase, base, and concrete pavement. Figure 4.2 (WisDOT 2019) shows such a relationship, with the area above and to the right of the curve indicating conditions that allow for effective rubblization. For PCC pavements that fall within the shaded “Remedial Action Required” area, it is recommended to utilize a “modified rubblization” process, as described in Chapter 3, or C&S/B&S, which retains more of the structural support of the existing PCC slab to compensate for low subgrade and base support.

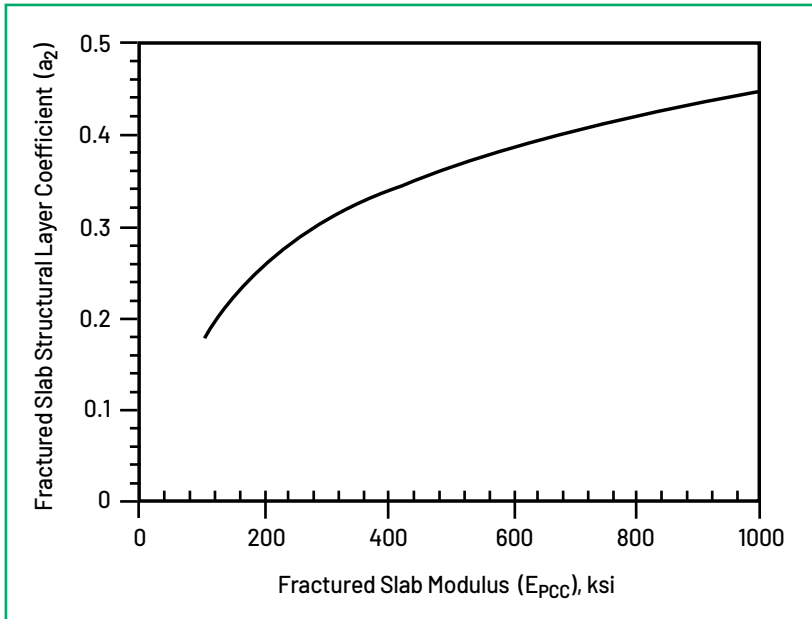
**Figure 4.4 Relationship between AASHTO structural layer coefficient and fractured slab modulus (AASHTO 1993)**

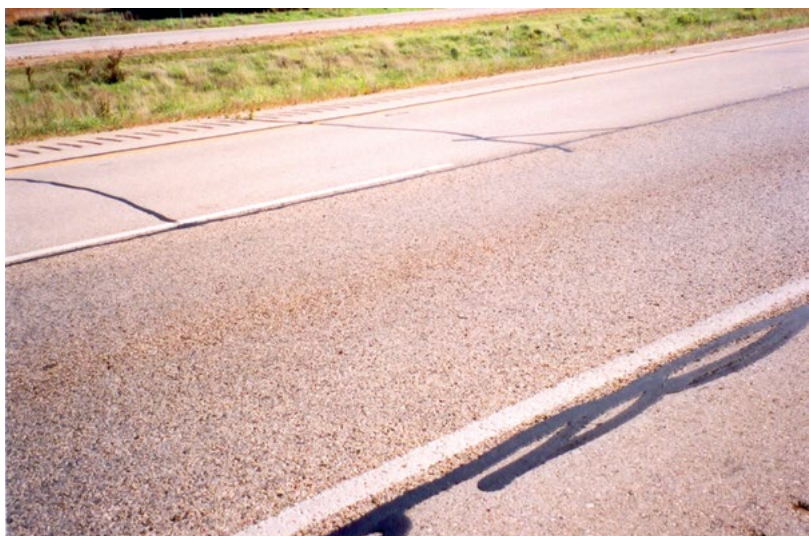
**Figure 5.2 Performance of SMA Overlay (near lane) on Concrete Pavement in Wisconsin after 8 Years** (Watson and Musselman 2022)

SMA mixtures have been found to significantly reduce the propagation rate of reflection cracking thanks to the combination of the gap-graded aggregate structure, higher binder content, and polymer modification. The Wisconsin Department of Transportation was one of the first state agencies to implement the use of SMA in the United States, and has been able to achieve durable and long-lasting pavements when incorporating this material. In the early 1990s, a pilot project was conducted on a section of I-43, where the existing PCC was overlaid with SMA in the mainline while the shoulders were overlaid with a conventional dense-graded mix. The Georgia Department of Transportation has also been a pioneer in the use of SMA. Some of the projects include placing SMA as an intermediate layer combined with an open-graded friction course surface layer to overlay PCC pavements in high-trafficked interstate routes. Results from these experiences have shown improved performance with up to 40 percent reduction in reflection cracking (Watson 2003).

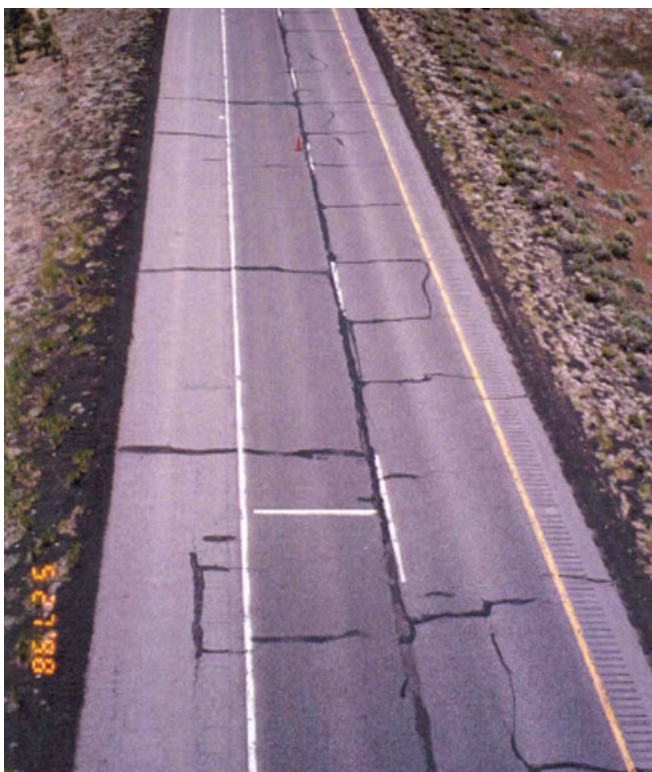
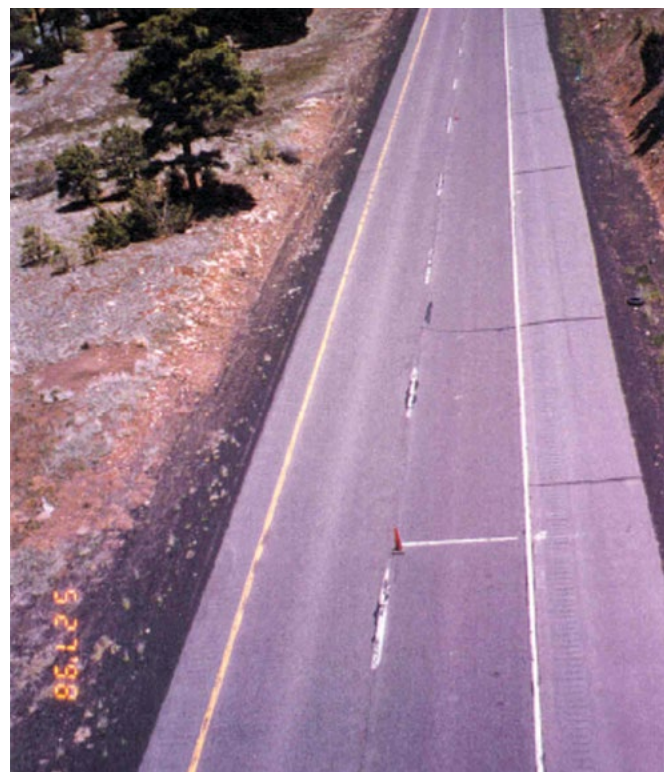
**Figure 5.4** I-40 SHRP Test section nine years after construction: conventional asphalt concrete (left) and asphalt rubber concrete (right) (Way 2000b)

The Arizona Department of Transportation (ADOT) has been using asphalt rubber mixes to rehabilitate concrete pavements since the early 1990s. An experimental section built under the Strategic Highway Research Program (SHRP) involved performing crack and seat of the existing jointed concrete pavement, followed by asphalt overlays with conventional dense-graded, asphalt rubber gap-graded, and asphalt rubber open-graded layers. The heavily trafficked section of I-40 in Flagstaff was in poor condition prior to rehabilitation but the asphalt rubber gap-graded mix exceeded performance expectations, providing benefits in terms of construction costs and time compared to the full reconstruction alternative and leading ADOT to adopt widespread use of asphalt rubber mixes throughout Arizona (Way 2000a).

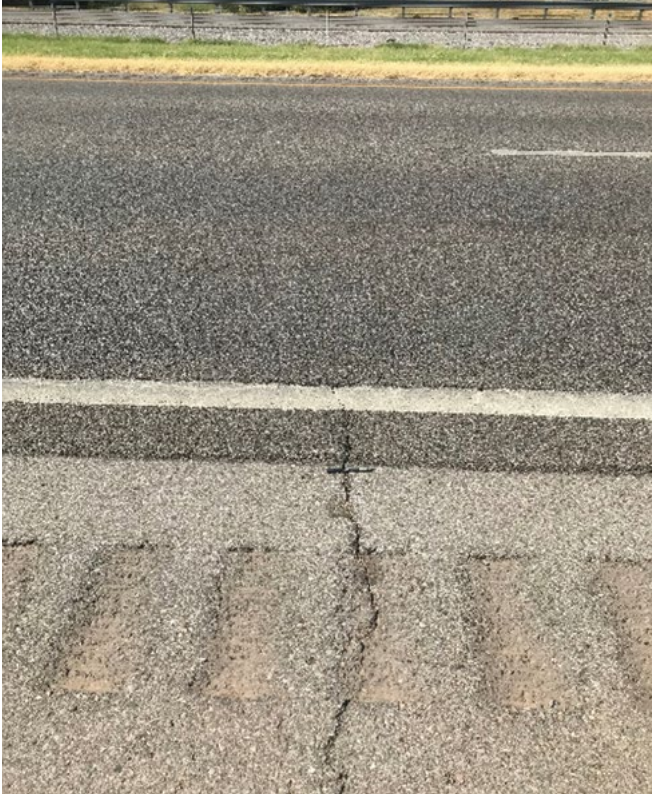
**Figure 5.6 HiMA mixture on Oklahoma's I-40** (Vargas-Nordbeck and Musselman 2021)

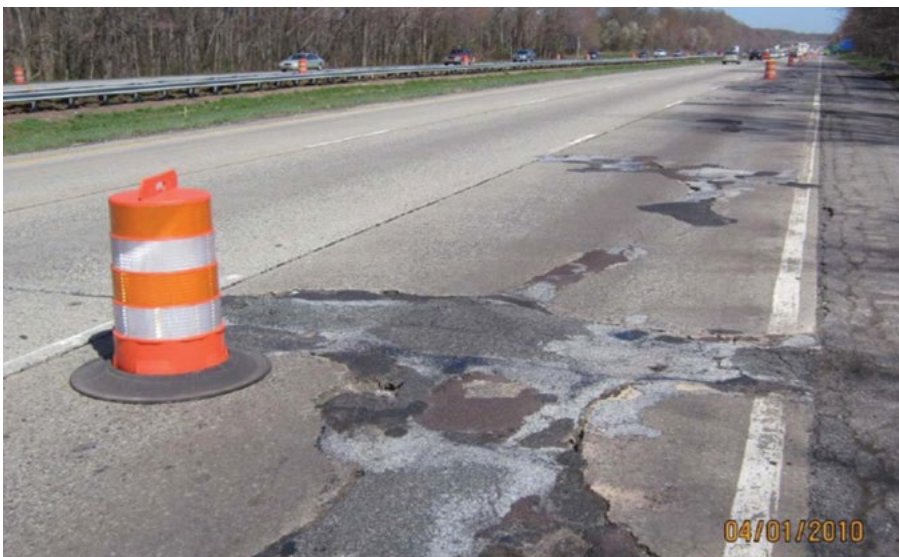
**Figure 6.1** Surface Conditions of I-295 JRCP Section from MP 45 to 56.8 in Burlington County (Courtesy of NJDOT)

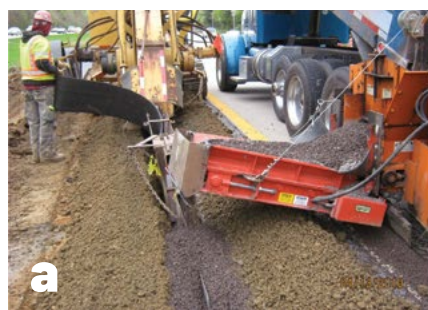
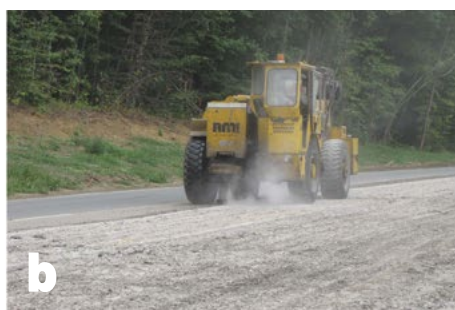
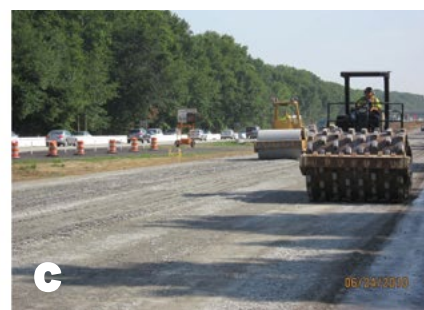
**Figure 6.3 Rubblization of JRC:** a) Installation of geocomposite edge drain, b) Rubblization of JRC, and c) Compaction of rubblized JRC (Courtesy of NJDOT)

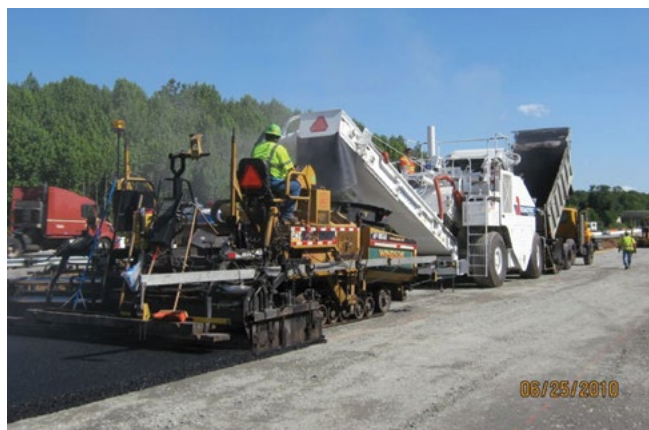
**Figure 6.4 Construction of BRBC Layer over Rubblized JRC** (Courtesy of NJDOT)

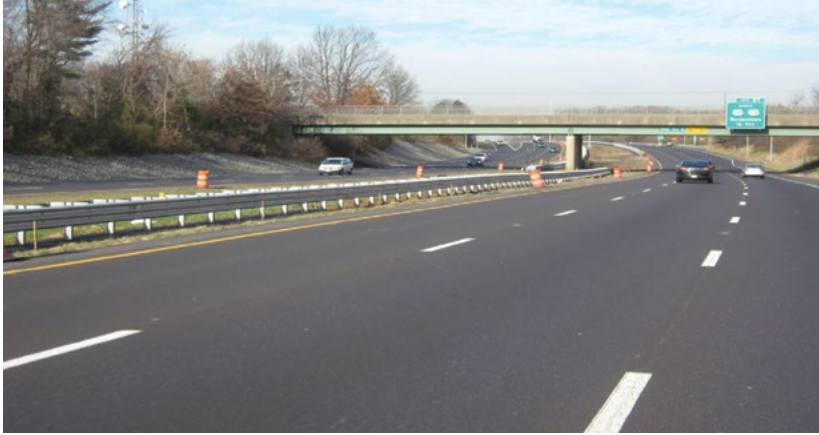
**Figure 6.5 I-295 Perpetual Pavement after 10 Years of Excellent Performance**  
(Courtesy of NJDOT)

In 2018, an assessment of the rubblized pavement section was undertaken using FWD and GPR techniques. GPR results showed that the average

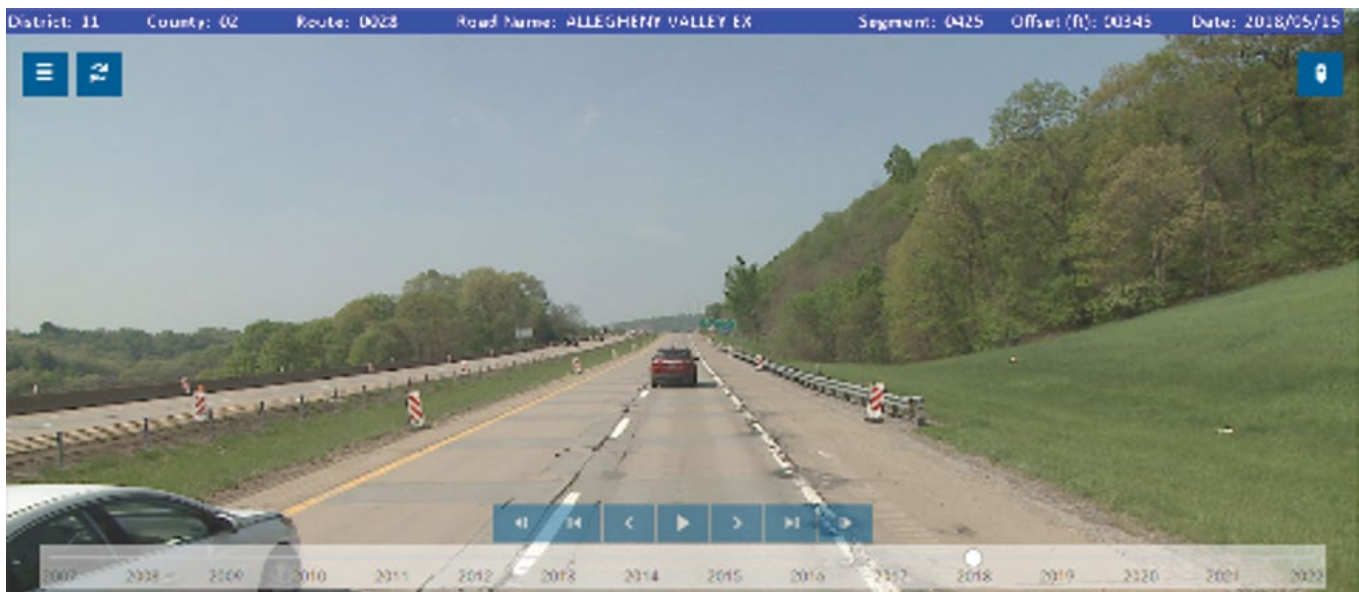
**Figure 6.6 Surface Conditions of SR-28, Section A55 in Allegheny County in 2018 Before Rehabilitation** (Courtesy of PennDOT)

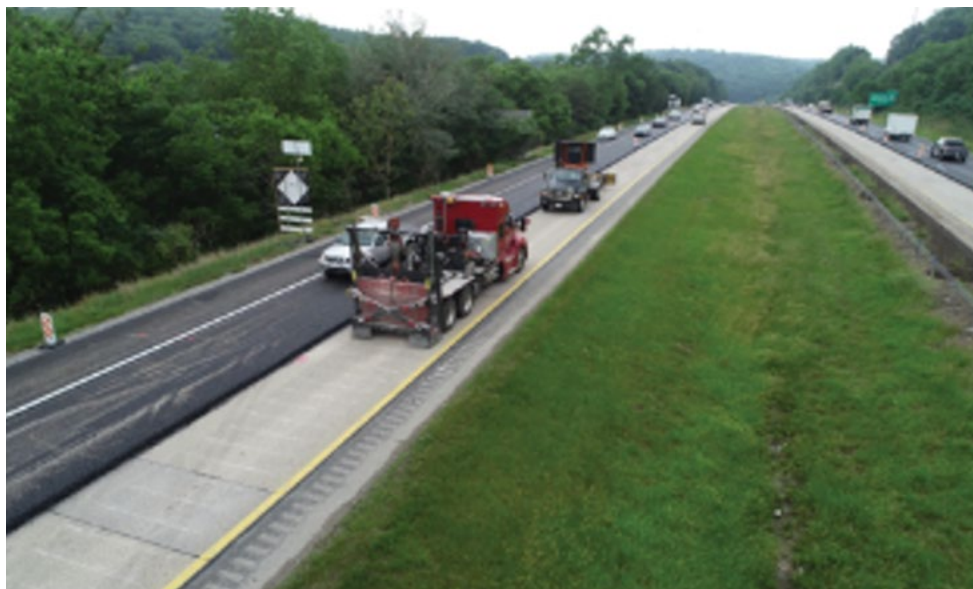
**Figure 6.7 T8600 Badger Breaker** (Courtesy of PennDOT)

For B&S fracturing, the pattern involved a 30-inch hammer lift height and a 24-inch hammer strike spacing. In contrast, the C&S pattern for the 10-foot outside shoulder was set at an 8-inch hammer lift height with a 24-inch hammer strike spacing. The 4-foot inside shoulder had a variable C&S pattern, ranging from 20 to 30 inches in hammer lift height and 24 to 30 inches in hammer strike spacing. Notably, the total hammer weight of the MHBT Badger Breaker hammers utilized was considerably lighter than the 12,000-lb hammer of the T8600.

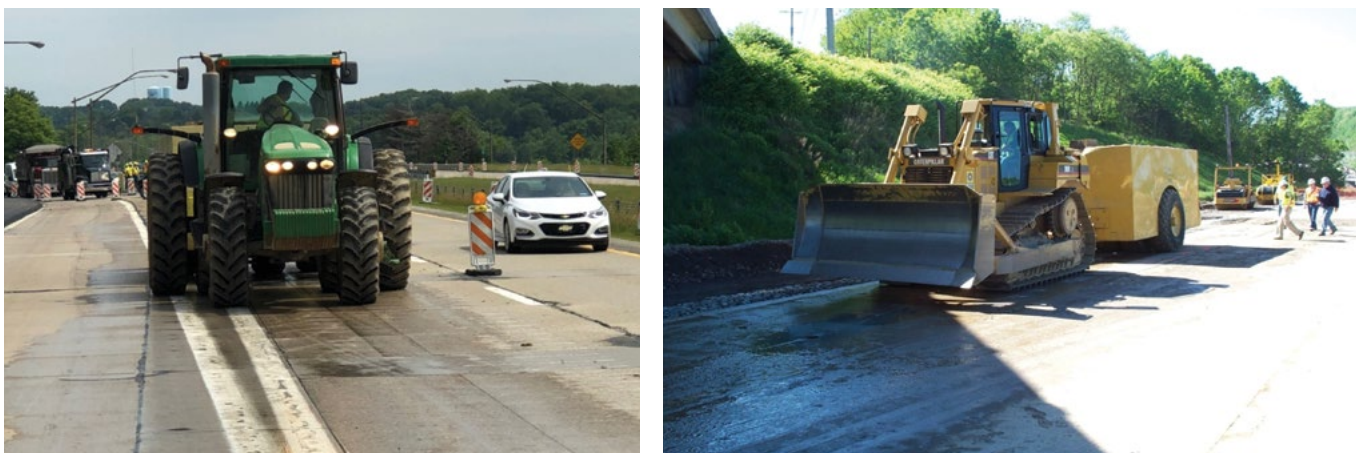
**Figure 6.9 Seating JRCF with 50-ton Pneumatic Tire Proof Rollers** (Courtesy of PennDOT)

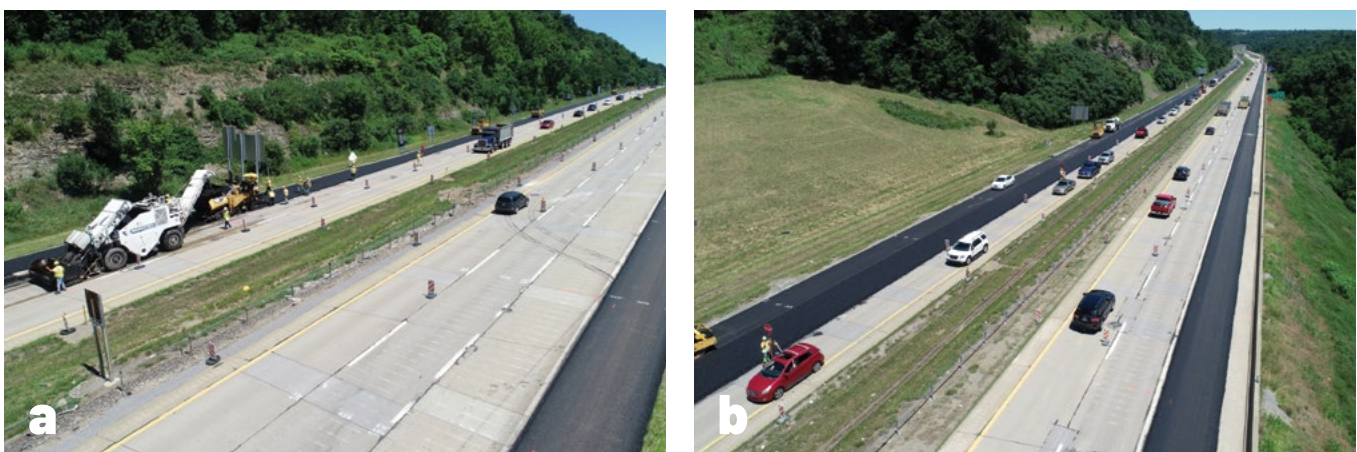
**Figure 6.10 Construction of Asphalt Overlay over B&S JRCP: a) Paving Exit Ramp, and b) Paving Main Lane**  
(Courtesy of PennDOT)

Upon completion of the final seating, the fractured mainline traveling lanes and shoulders were surfaced with an 8.5-inch asphalt overlay. This overlay on the mainline traveling lanes comprised a 4.5-inch 25-mm Superpave WMA base course, a 2.5-inch 19-mm Superpave WMA binder course, and a final 1.5-inch 9.5-mm SMA surface. A PG 64-22 binder was designated for the base course, while the binder and surface courses utilized a PG 76-22 binder. In addition, the binder course and SMA mixtures were designed following the Long-Life Asphalt Pavement (LLAP) specifications to ensure extended longevity. The overlay for the shoulders was similar to that of the mainline traveling lanes, except for the wearing surface, which was a 1.5-inch 9.5-mm Superpave WMA mixture.
